Homeowner's Helper of Morris, LLC.
Home Inspection Services
17 Anderson Road
Wharton, New Jersey 07885
(973)328-8920

March 10, 2008

As per your request a visual inspection was performed at 1313 Mockingbird Lane, Somewhere, New Jersey. The inspection was performed in accordance to the State of New Jersey and The ASHI Standards of Practice. These standards are available at www.ASHI.com or through my office upon request. This inspection report does not in any way suggest a guarantee or warrantee of any kind. For more information regarding limitations please review the contract you signed with Homeowner's Helper of Morris, LLC. prior to the inspection.

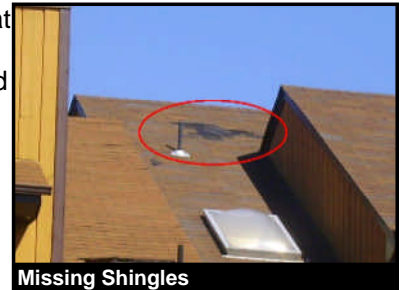
Type: Asphalt strip shingles.
Condition: Roofing material was in satisfactory condition at time of inspection. Missing and loose shingles observed on neighbor's roof. Roof on inspected unit appears to be newer than others. Check with Association for roofing material and maintenance responsibility.

Missing Shingles

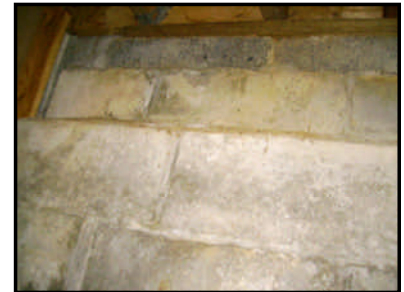
Condition: Efflorescence observed.

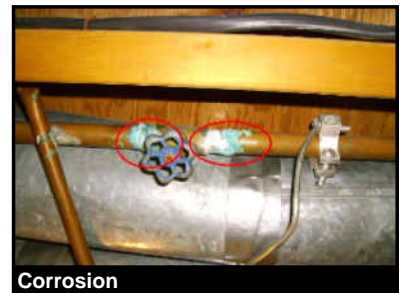
Repairs recommended from a licensed Plumber. Corroded.

Corrosion

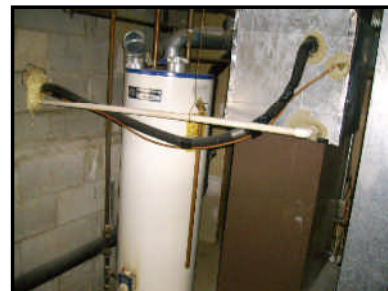
Approximate Age: Approximately 6 to 10 years old.

Comments: Older unit. Budgeting for replacement recommended.

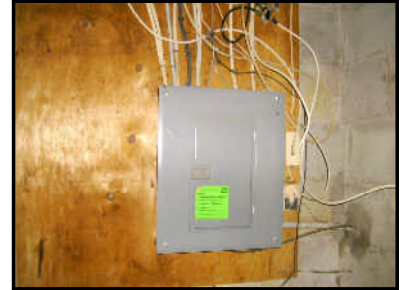
Panel Characteristics: 100 amp panel installed. This is a smaller amperage panel and may not be adequate to run all of today's appliances. Upgrade may be necessary.

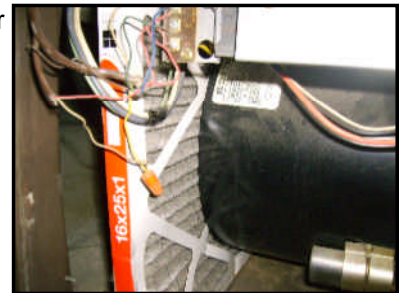
Unit Condition: Older unit installed but operating. Budgeting for a replacement in the future recommended. Recommend unit is cleaned and serviced prior to heating season. Replace filter regularly.

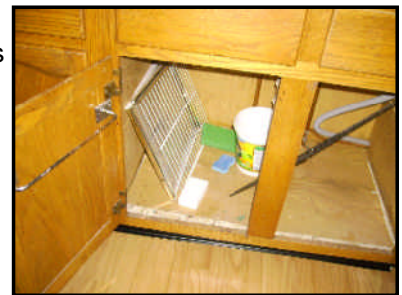
Condition: Repairs recommended from a licensed Contractor. Hardware is either missing or does not function properly.

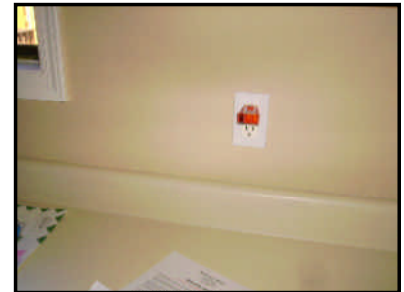
Outlets And Switches: GFIC are not currently installed. Correction recommended from a licensed Electrician. Consult with local building officials for code compliance.

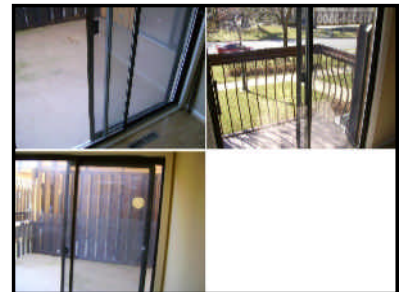
Repairs from a licensed Contractor recommended. Adjustment recommended on one or more units for normal operation. Fog between glass pains. This means seal is broken and window has lost its insulation ability. Physical damage observed.

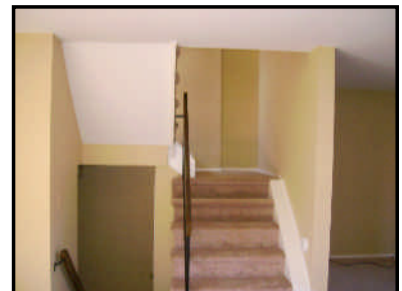
Repairs recommended from a licensed Contractor. Loose.

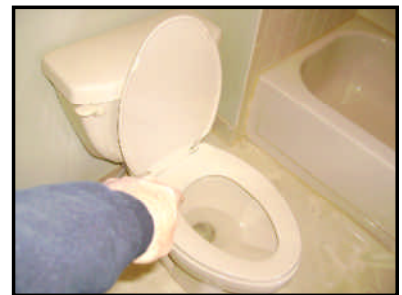
Condition: Repairs recommended from a licensed Plumber. Toilet is loose. Replacement of wax ring and tightening to floor recommended. Failure to do so may cause water leakage and damage.

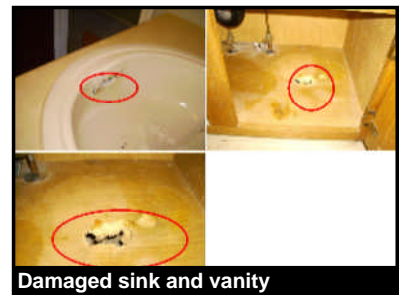
Condition: Replacement from a licensed Plumber recommended. Cracks in fixtures observed. Excessive wear of porcelain observed. Fixture is damaged or broken beyond repair.
